Home Inspection Report

11900 11920 sw Iron Horse Lane
Beaverton, Oregon
Inspection date 08/11/2011
(Section three of three)

Prepared for: Actual inspection / Section Three

Prepared by: The Home Tester
10555 SW Tigard St. #57
Tigard, OR 97223
Ben Tester
503-515-1833 CCB# 164921 OCHI # 912

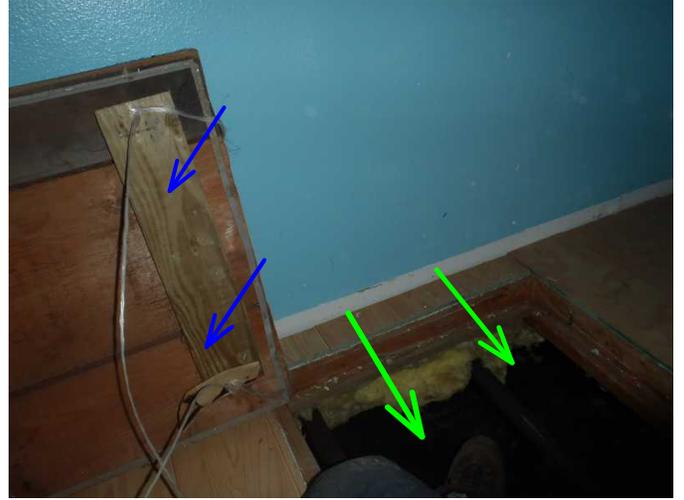
access to crawl is noted in bedroom closet floor and hatch needs insulation and weather stripping to seal...

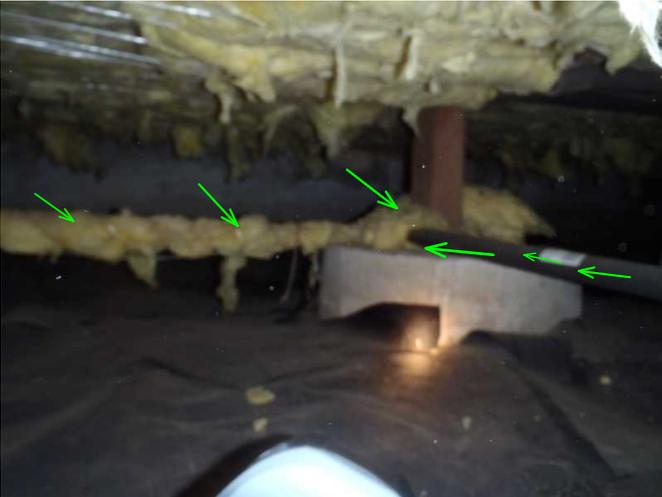
main copper water entry line is noted here and is insulated...good...ABS sewer exit is noted at right center...

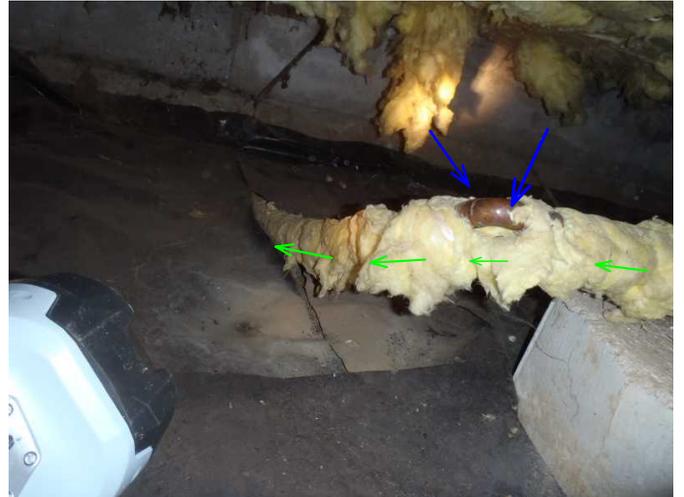
most of water feed lines are noted insulated...but will need random new insulation where pulled back...

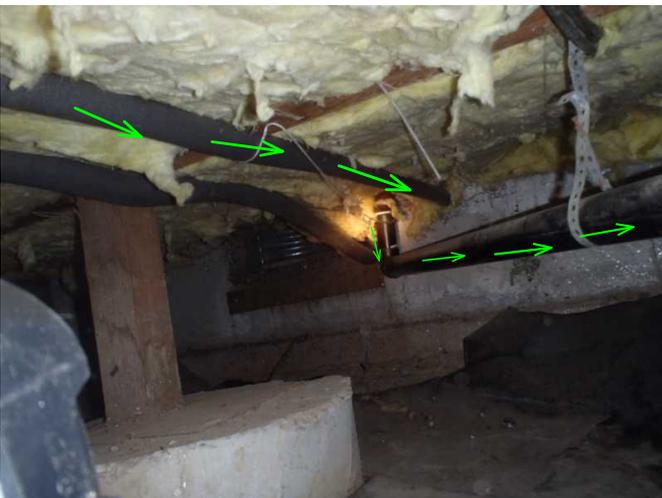
most water lines are noted insulated with insulation or foam...ABS sewer exit lines are noted from both kitchens..newer

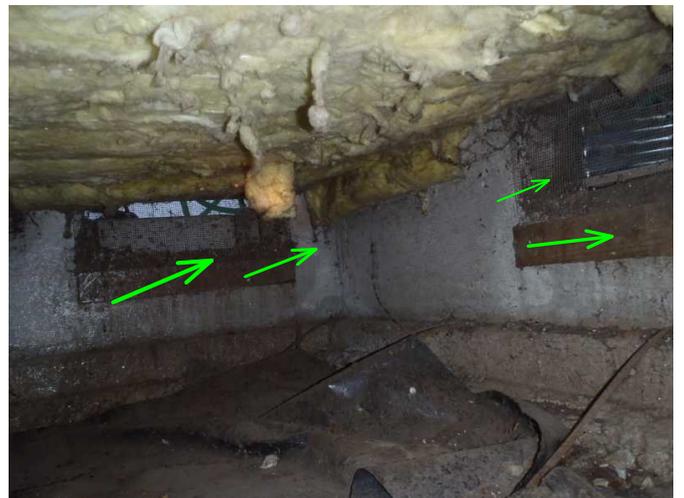
most all the vents are noted screened....monitor all vents to be sure screens are in tact to not allow in critters...

Main - Crawl Space - Ventilation: Vents - monitor and maintain vents with screens and keep screens secured...appears past critter access has been noted...appears most vent screens have been repaired, assess all and add screens to any missing screening found...down and hanging insulation is noted in several areas from past critter intrusion...recommend adding metal vent wells at every vent exterior area...

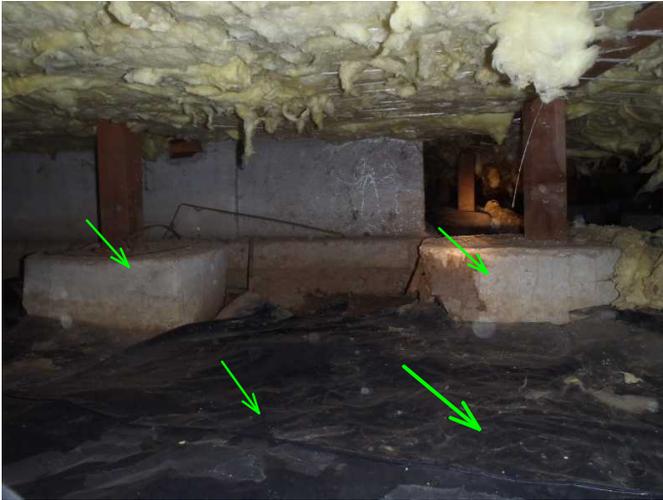
all of crawl is noted with vapor barrier and posts are raised and dry...and solid on piers....

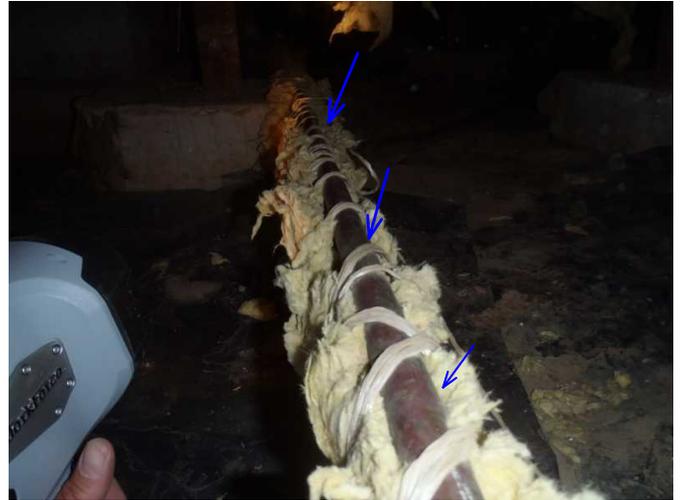
more areas noted that need insulation...main copper water feed lines...

Water Lines: Galvanized and copper and c-pvc - most all potable water lines are insulated...appears some need repairs and added insulation from past critter damage...see photos

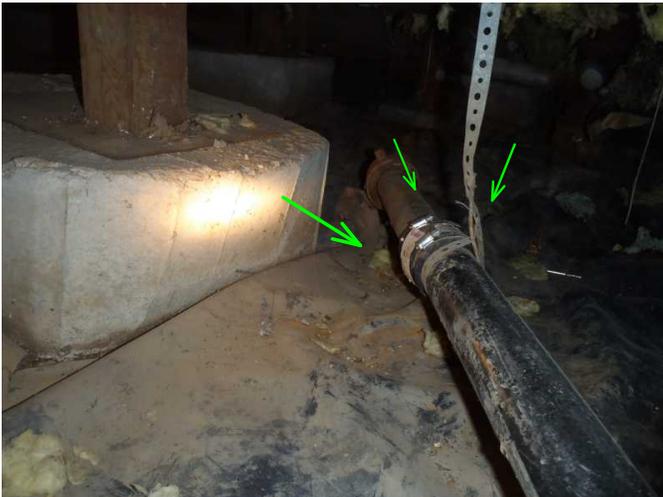
ABS meets original sewer exit drain and is noted clamped as needed...good...no drips or leaks...

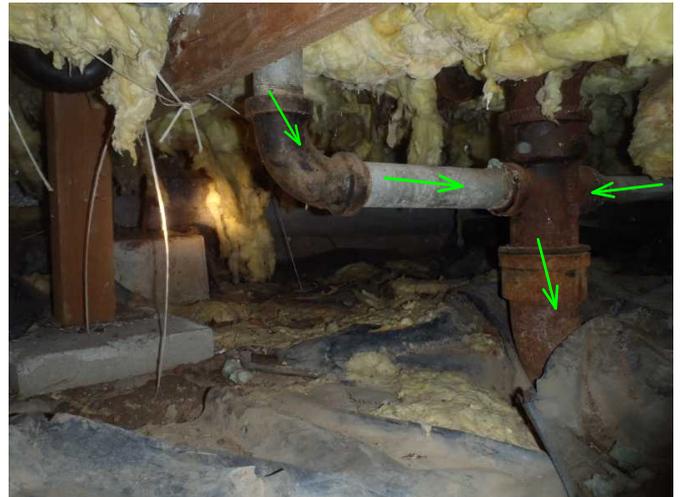
11920 bath exit drains are original and noted no drips or leaks below as well as in area...

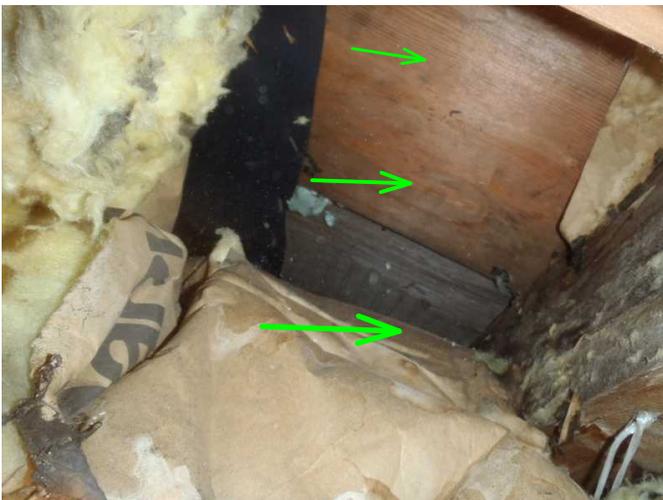
some areas are noted with flooring replaced with plywood under bath areas in 11920 sub floor area where insulation down...

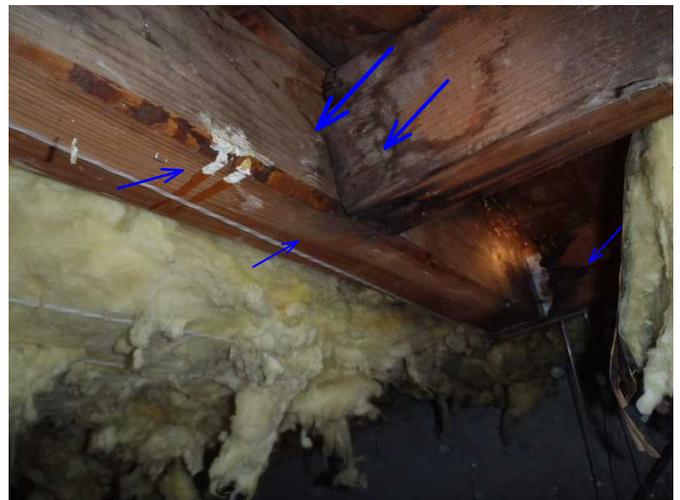
some beams are noted with staining and are noted solid...repairs were performed...

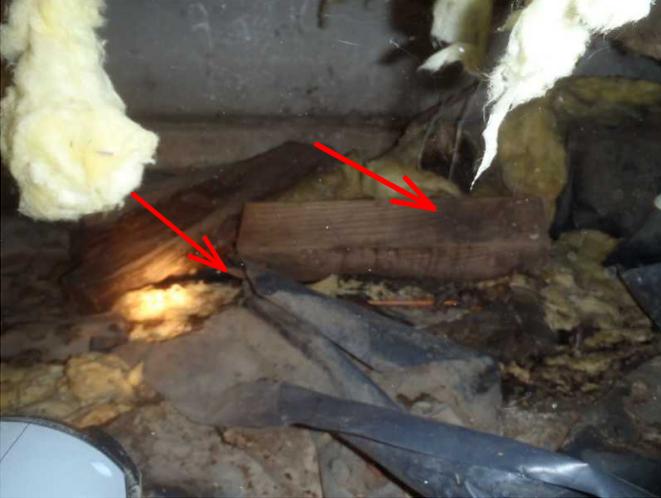
some areas over vapor barrier have wood debris and needs removal...

Main - Crawl Space - Vapor Barrier: plastic over earth... - all of crawl has vapor barrier and no standing water noted...good...there are areas of damaged insulation, wood debris and critter feces noted in vapor barrier that need removal and clean up to remove contaminated areas from future use...see photos

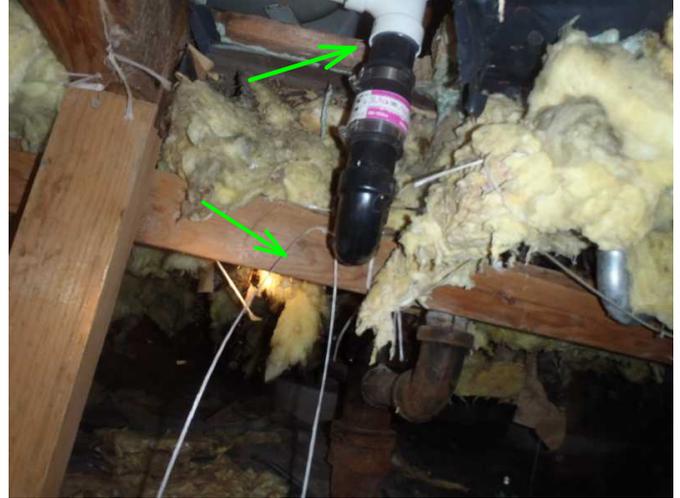
here is same area under 11920 tub area and has new ABS trap as well...

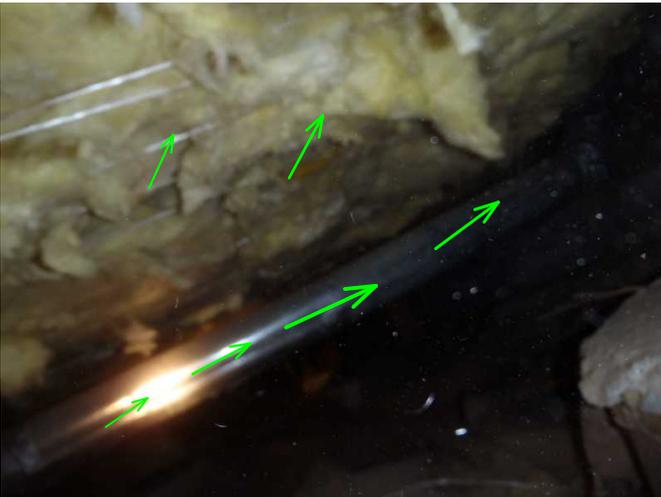
insulation is noted secured to under floor areas and not able to remove...11920 dryer vent is noted solid and secure...

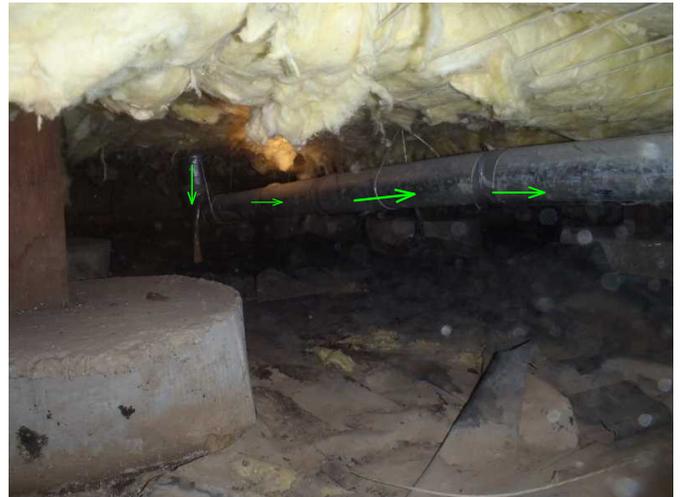
dryer vent is noted with no lint leaks and solid from laundry to exiting area at back of home...

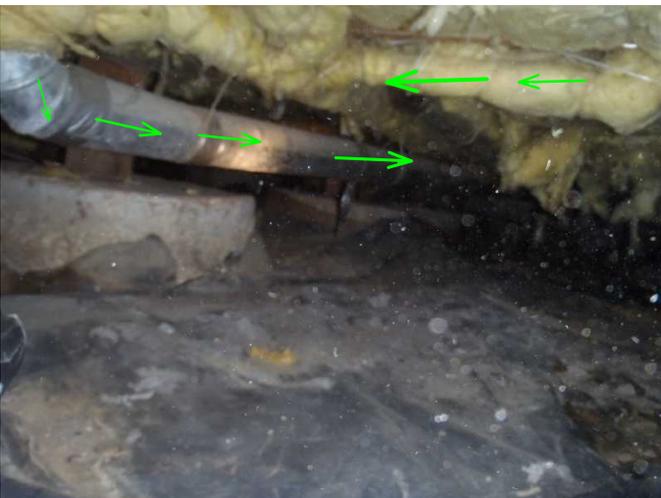
most all water pipes are noted here insulated...and 11900 dryer vent duct is noted solid to exit as well..

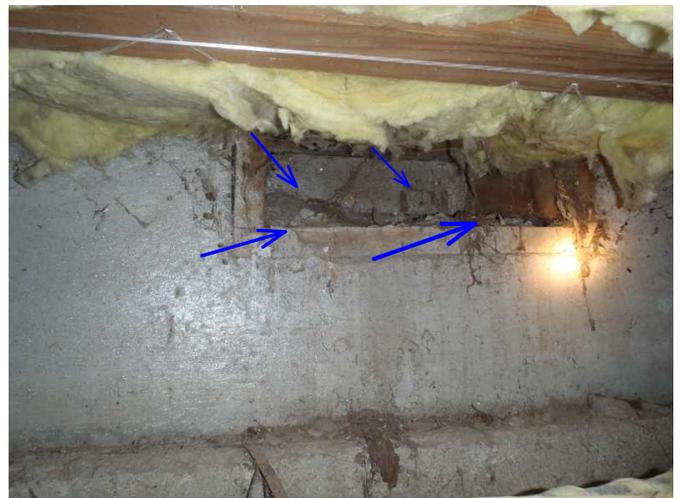
here is vent in front of home that needs screen...is covered with wood..but is recommended to be kept open to vent air...

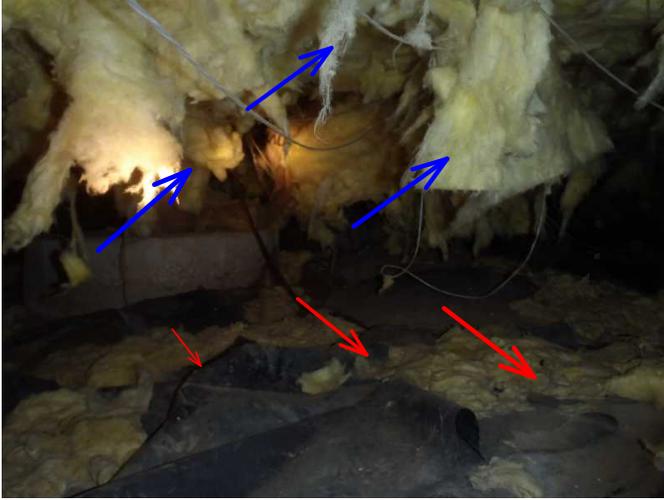
here is past evidence of insulation pulled down by critter infestation...and is also on vapor barrier...remove..

Main - Crawl Space - Insulation: Batting - under floor insulation is noted and appears was added after structure was built...random areas of insulation are noted down and nesting has occurred...remove all nesting on vapor barrier and re-install all loose and missing insulation to continue to provide insulated areas to contain heat...

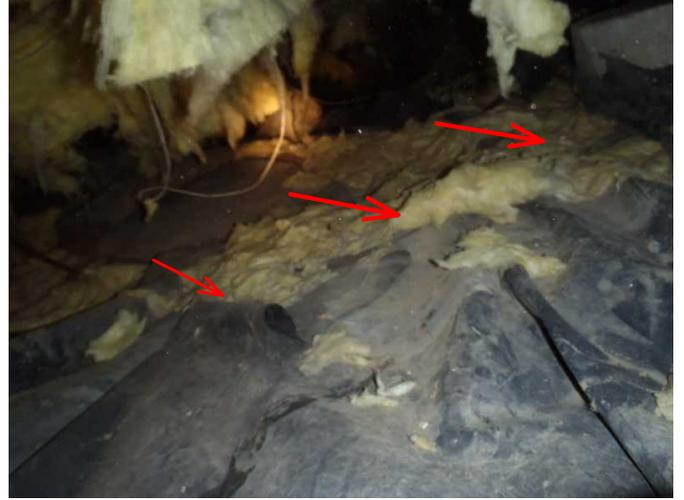
many small areas under structure noted with insulation down on vapor barrier and old critter nesting noted..remove...

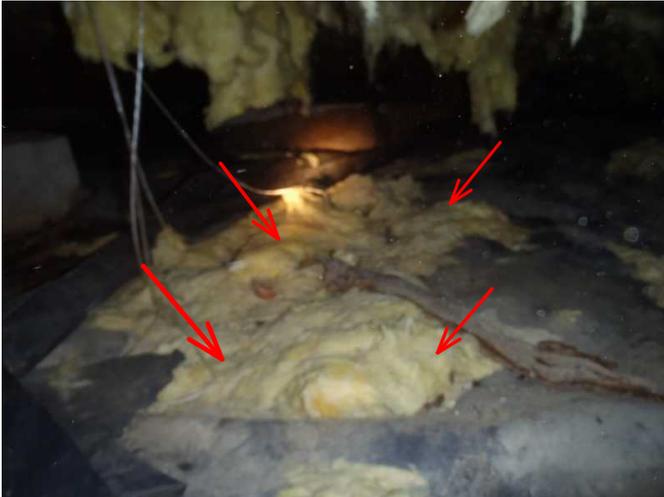
critter nesting is also area where fecal matter and urine is in the insulation..contaminated...remove...

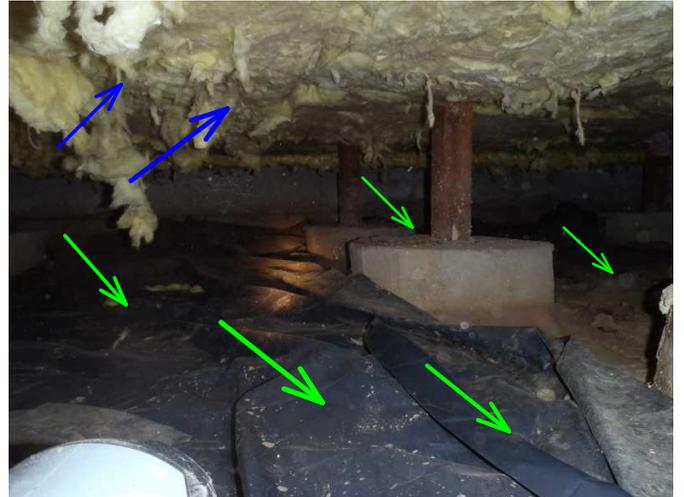
most crawl is noted in very clean and dry condition...posts are raised and vapor barrier in place...insulation shredded

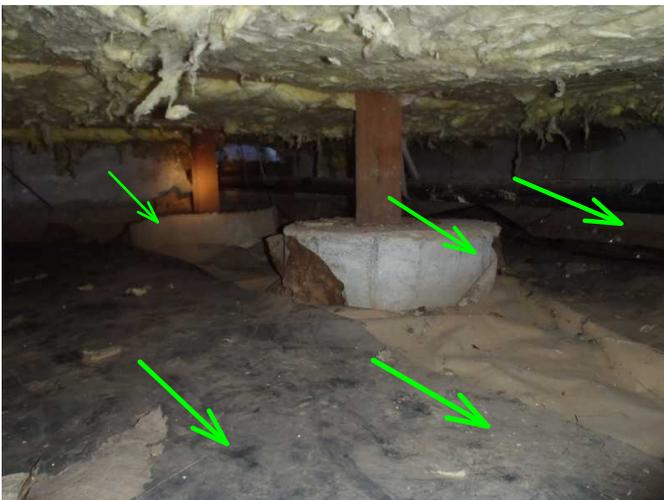
another view of crawl and most areas are noted fine...dry and posts raised...

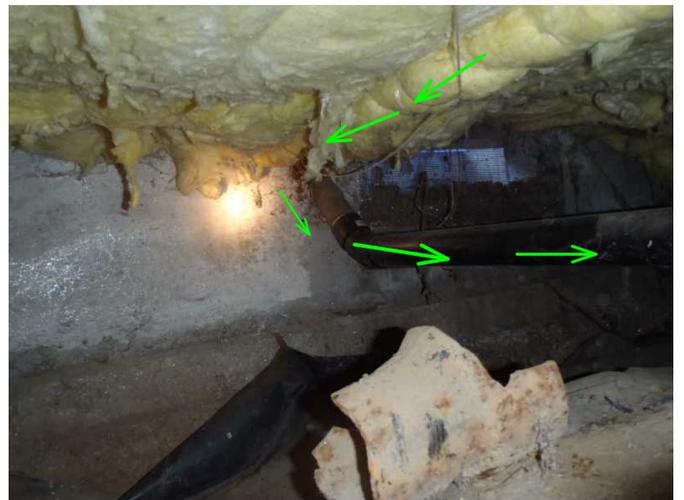
this is area under 11900 kitchen and sewer exit drain is also ABS and is solid and no leaks noted...

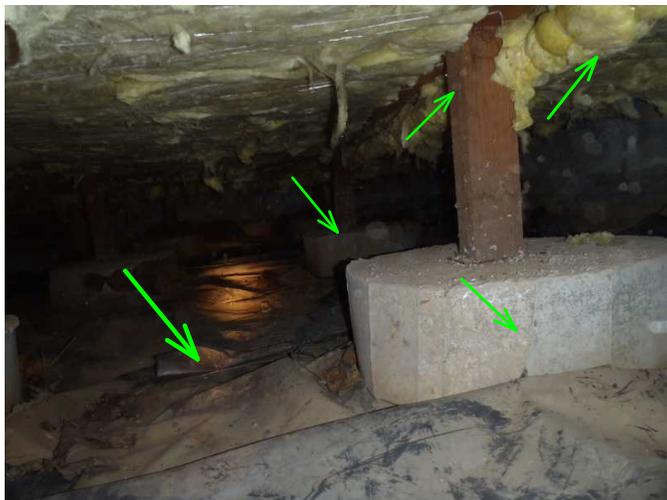
can see the under floor insulation is strapped with string and is secured to structure...damage will occur to access

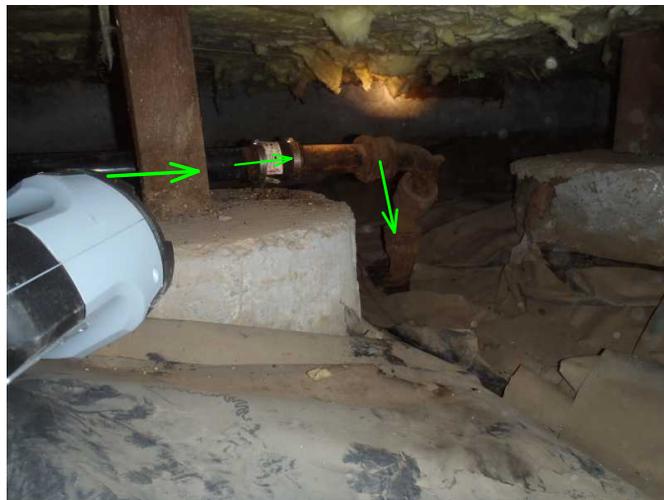
here is the kitchen exit drain and is connected to original galvanized exit drain...clamped well...

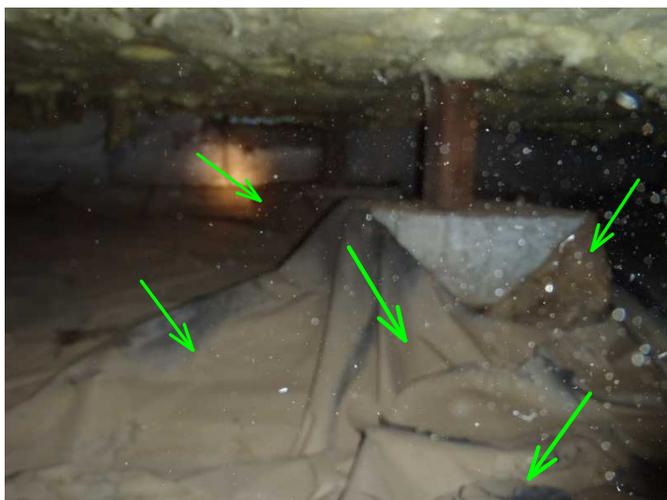
this is under bedroom areas of 11900 and all is dry and solid...raised posts and peirs solid..

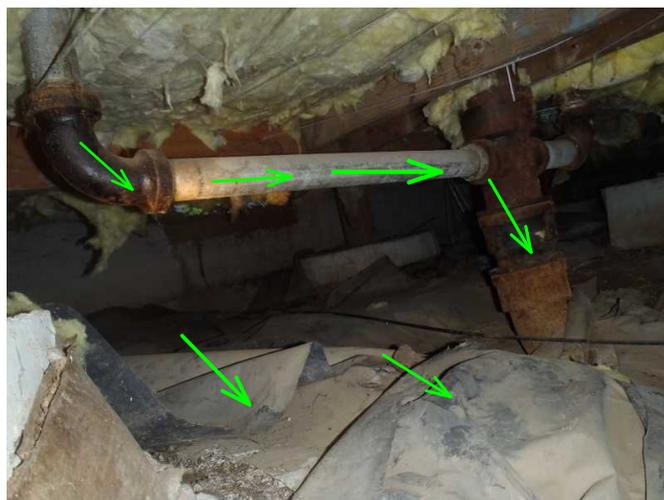
this is under 11900 bath areas at sewer exit drains and no leaks noted at drains or area around and no wet insulation...

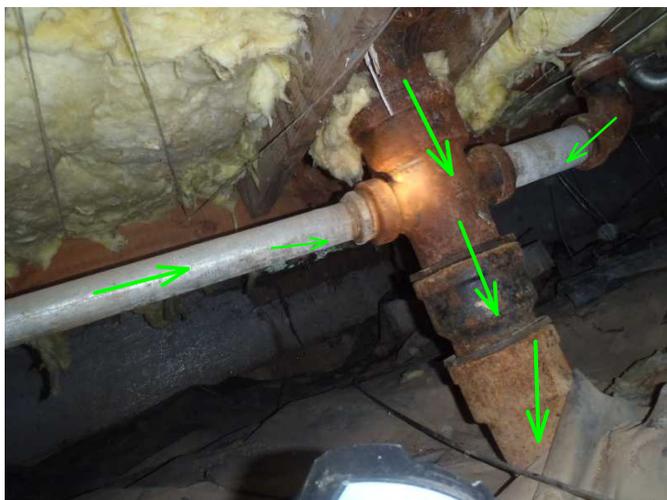
under bath area is close up and all connections are dry...galvanized and cast original exit drains noted...

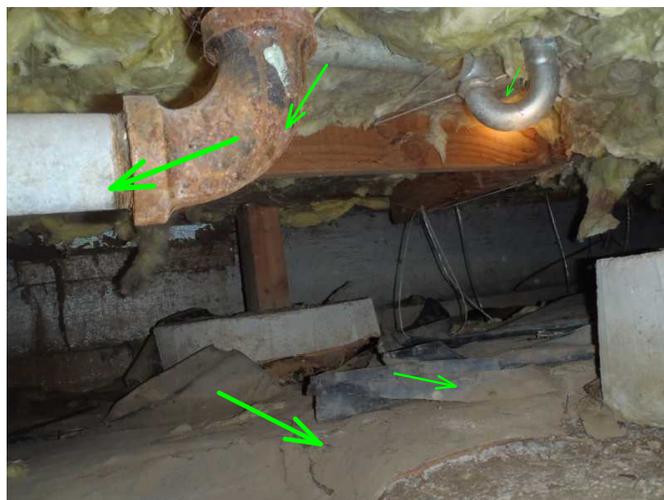
some rust is noted at exterior of cast exit drain, but no leaks noted...good...dry at all areas of crawl vapor barrier..

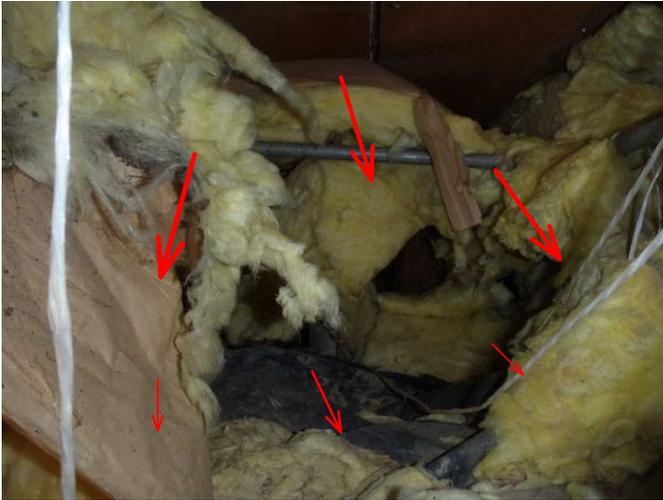
here is area between baths of both units and noted insulation is down and nesting has occurred...remove all contaminated

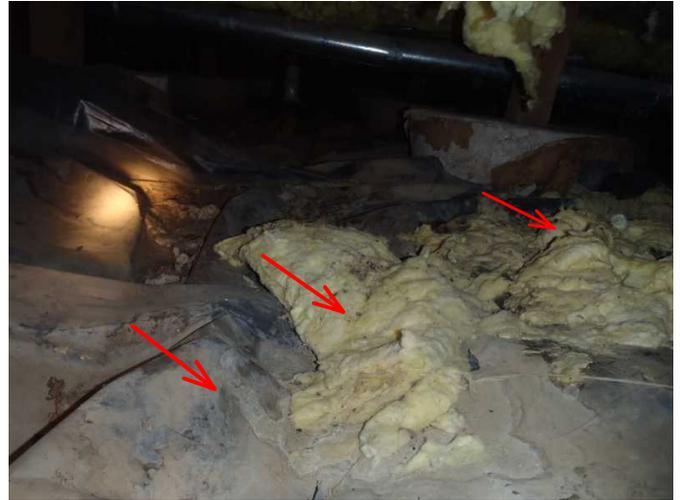
the vapor barrier is noted here with contaminated insulation with critter fecal and urine matter and needs removal..

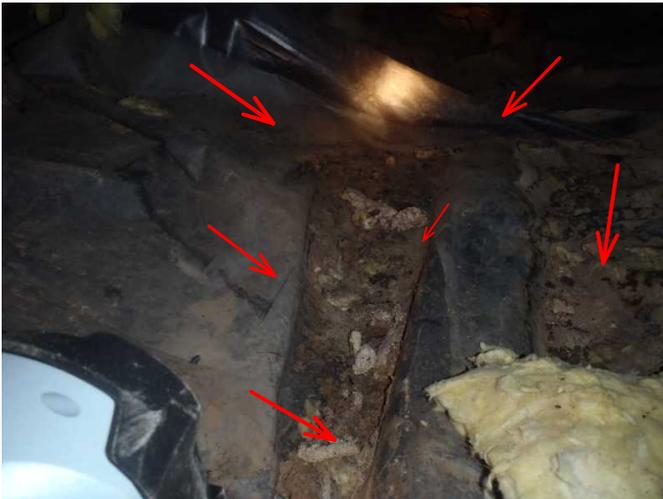
there is also an area where appears is critter toilet area...fecal matter and urine are noted on vapor barrier...remove

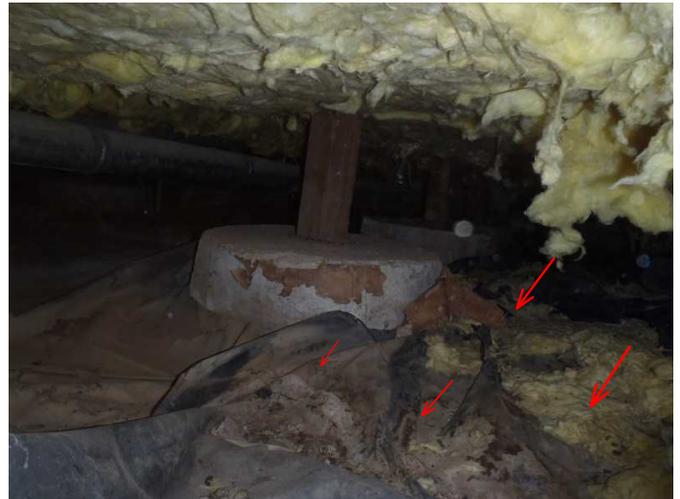
more downed insulation noted...appears was past issue...and vents were closed up, but repairs not performed...

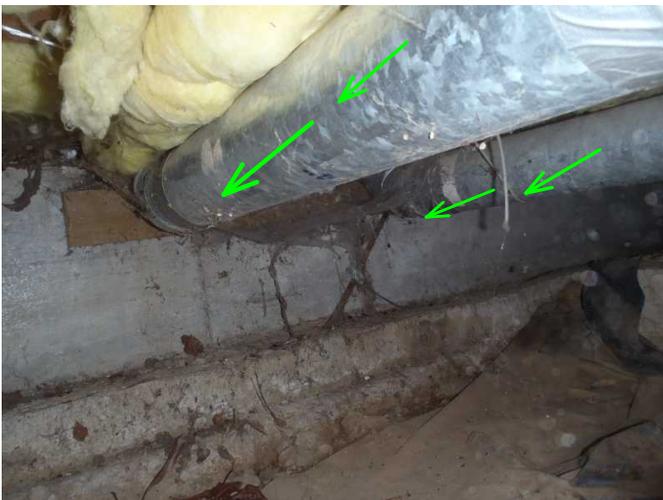
here is back area of home where dryer vents exit and are noted solid and no lint or leaks noted...

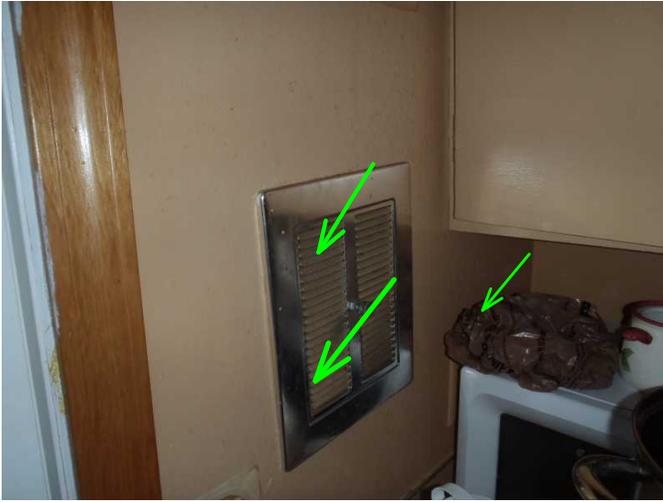
both side wall kitchen exit fan vents by stove are
noted operable..found switches for both and both ran
fine...
