# Home Inspection Report

3905 sw 183rd Ave Portland, Oregon  
Limited to Roof Inspection only  
Roof Inspected & Certified for 3 Years as is  
(see certification notes in report)

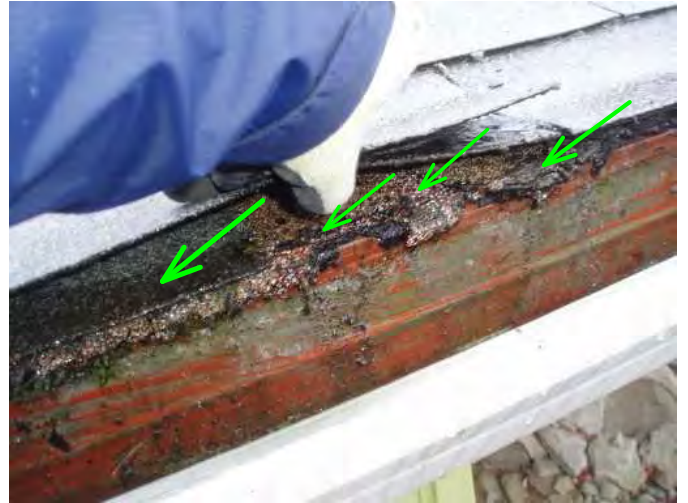
two layers of roof are noted...top layer is secured well...

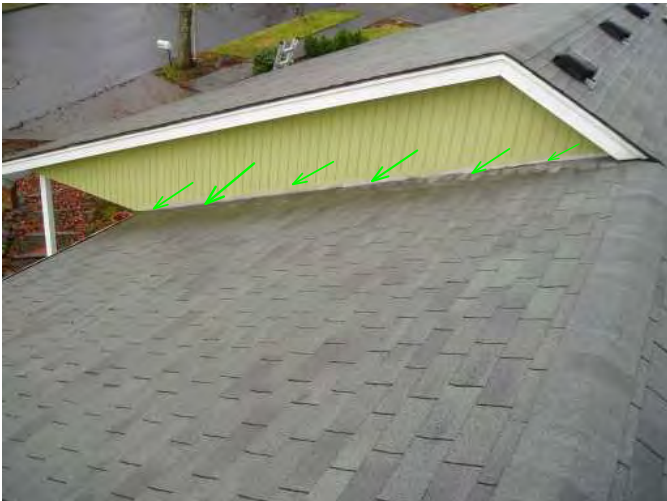
step flashing is secure and performing well in rainy day flow....good..

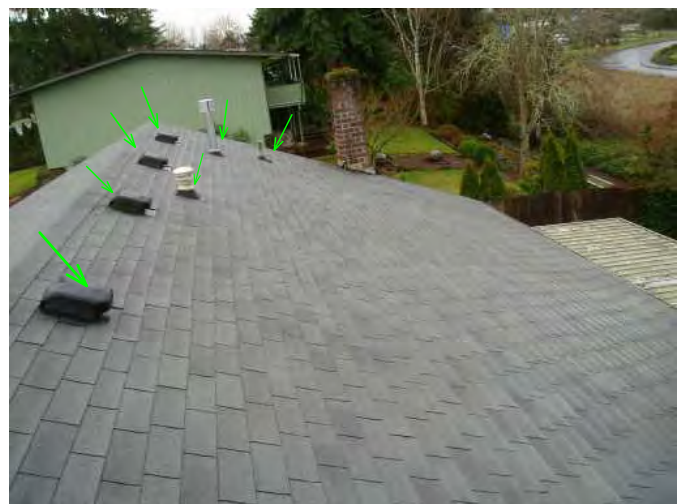
rest of attic vents are noted here fine..."b" vents are flashed well and plumbing vent is flashed tight and sleeve solid...

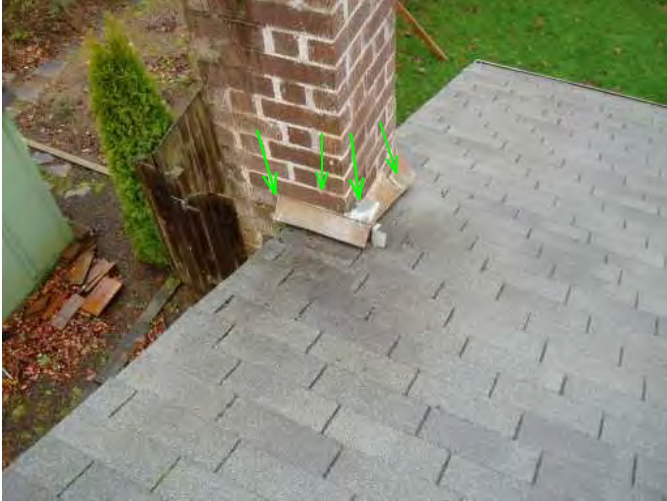
brick chimney is flashed with step flashing and covered well with counter flashing...no apparent leaking noted...

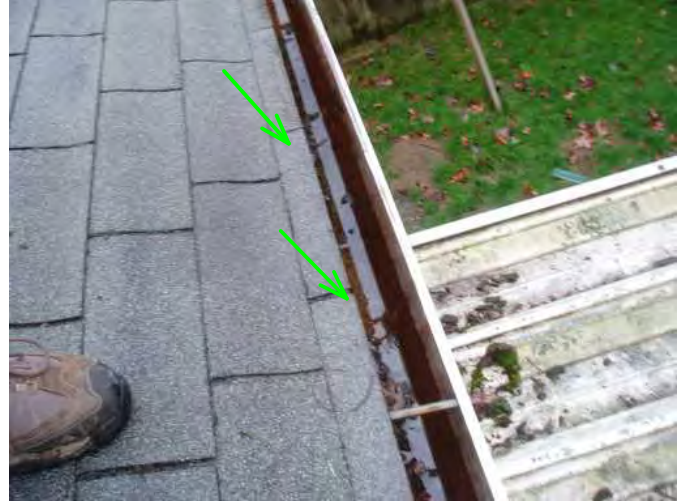
gutters are noted draining well as it is a rainy day today...clean as well...

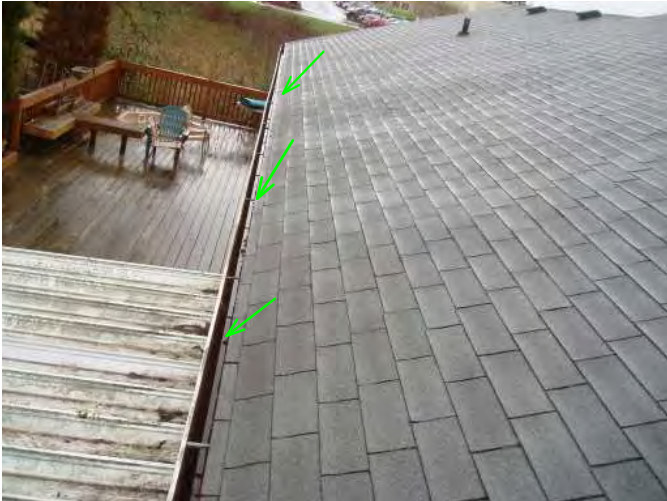
gutters are solid to home and draining well here as well...

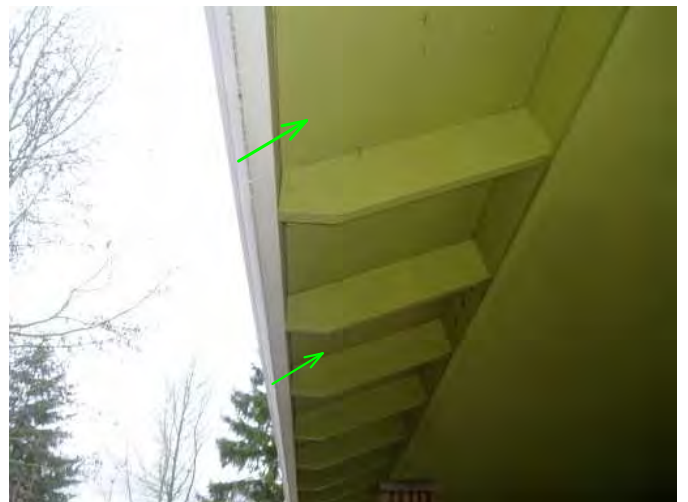
soffits under overhang of roof are noted solid and sound...no soft or rotted wood noted...good..

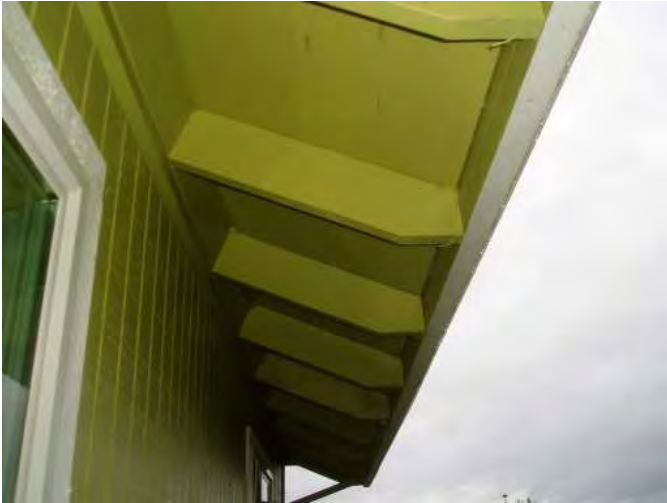
same noted here at soffits at back of home...good...

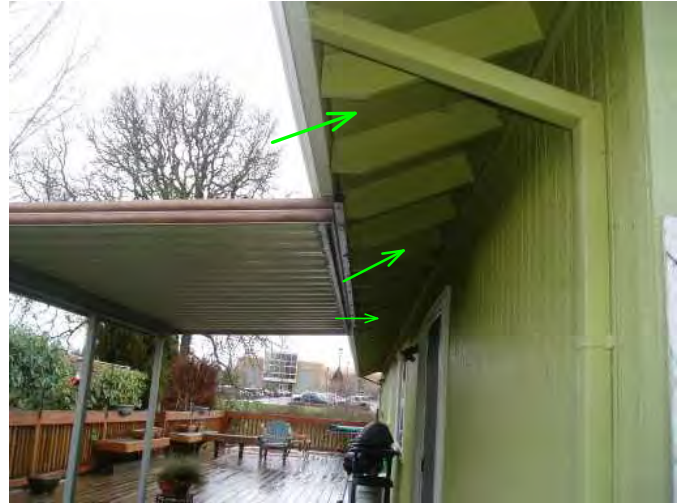
awning and soffits here are noted solid and dry...good...

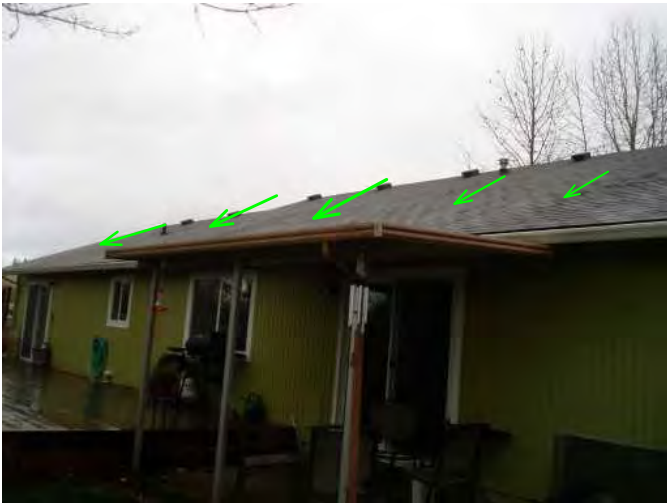
view of back roof is noted as draining fine...

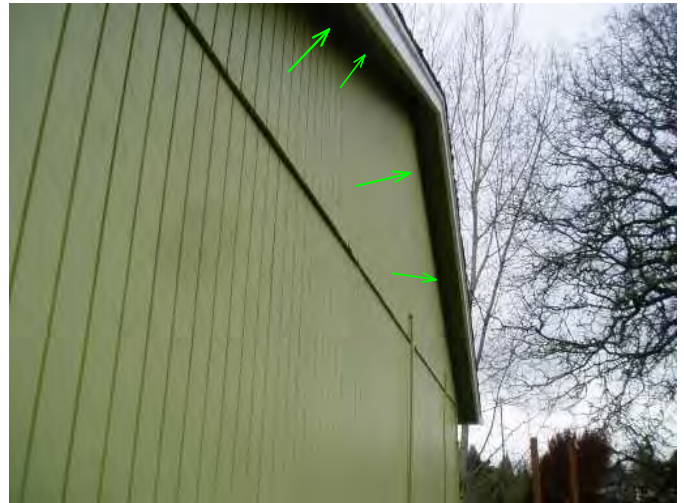
both ends of home has solid and dry soffits as well...no leaks noted...wood is solid....good....
